Troubleshooting Guideline for CIROS v7.1

Last updated by | Hoi Yee Cheang | 8 Sept 2022 at 17:30 CEST

Note: This guideline is also suitable for v6.4.6 and v7.0.

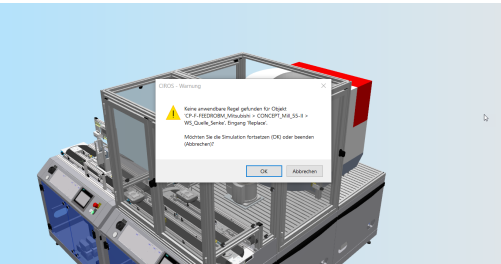
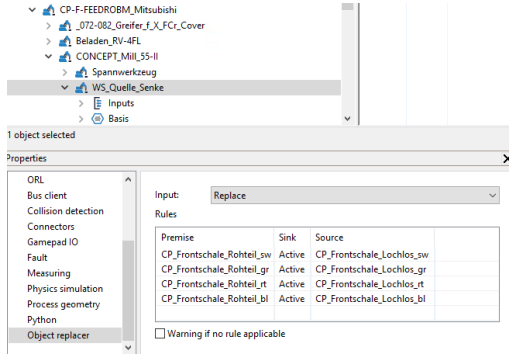
| Issue | Cause | Notification | Action |
|--|--|--|--|
| <p>*CP-F-FEEDROBM</p> | <p>Replace rule warning is activated, and the part number defined in MES4 is not part of the rule.</p> | <p>NOT ERROR, will stay like this.</p> | |

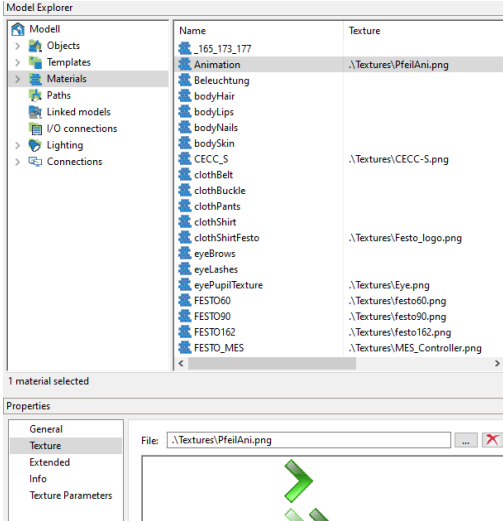
| Issue | Cause | Notification | Action |
|--|--|--|--|
| <p>*Renderer Texture files not found during model loading.</p> | <p>[1] Texture folder does not exist in the project folder.</p> <p>[2] Wrong path to the texture file.</p> | <p>"Renderer: Texture file '... ..\Textures\jpg' not found ."</p> | <p>[1] Copy the Texture folder from another CIROS CP System project of same CIROS version to the project folder.</p> <p>[2] In "CIROS/Model Explorer/Materials", select the material with wrong path and update to the correct path in "Properties/Texture". Use relative path (e.g. ".\Textures\picture.png") to make sure the path is correct after the project is moved.</p> |

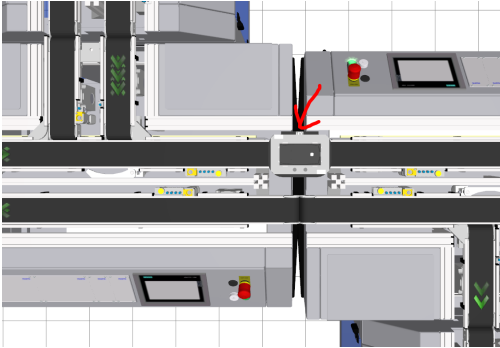
| Issue | Cause | Notification | Action |
|---|--|---|---|
| <p>*Simulation Carrier stops and does not drives to another belt.</p> | <p>[1] Z-coordinate of the model is not 0.</p> <p>[2] MES4 topology setting is not correct.</p> <p>[3] MES4 buffer position restriction does not allow the part.</p> <p>[4] The model is not snapped properly.</p> | <p>[4]</p> | <p>[1] Move Z-coordinate to 0.</p> <p>[2] Make sure MES4 topology is correct.</p> <p>[3] Make sure the part is allowed in MES4 buffer position restriction.</p> <p>[4] Drag and snap the model in CIROS Model Window again.</p> |
